# Development of End Fittings for Beryllium Structural Tubing

ER 1668-14

#### FINAL REPORT

July 1967

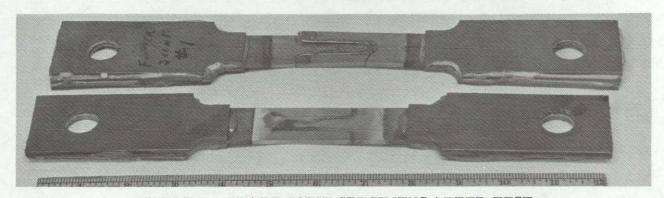
FIGURE 5. BRAZE JOINT SPECIMENS AFTER TEST

two of these specimens before and after test. The contempated advantage of this design was to eliminate the eccentricity in the joint, thus, theoretically, there were no bending stresses to cause delamination of the beryllium in the sensitive Z direction.

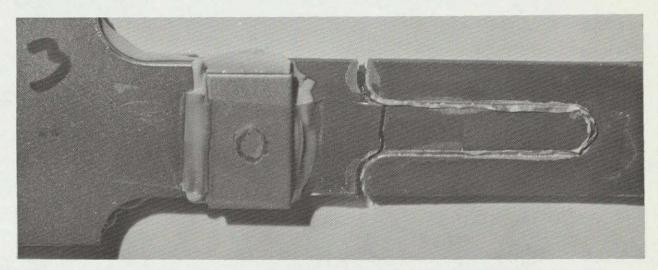
FIGURE 6. BRAZED FINGER JOINT; SPECIMEN NUMBER 3

insufficient braze shear strength, and the third (Fig. 6) because of the reduced tension section at the base of the finger.

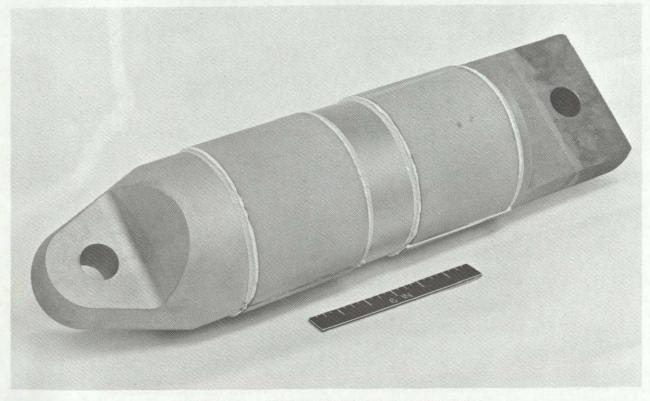
FIGURE 12 FIXED END TEST ASSEMBLY

The first fixed end test fitting (Fig. 12) failed at a tensile load of 75,900 pounds. The failure occurred in the adhesive joint, largely as an adhesive failure at the beryllium surface (Fig. 13). There are two possible causes of the premature (80,000-pound design strength) failure. The most likely explanation is the nonuniformity of the adhesive film thickness after cure which varied from approximately zero to 0.0055 inch. This nonuniformity resulted in concentration of the load in local areas of the joint. The concentration was confirmed by the patterns developed in the stress coat applied to the lap strap and the beryllium tube (Fig. 14 and 15). The

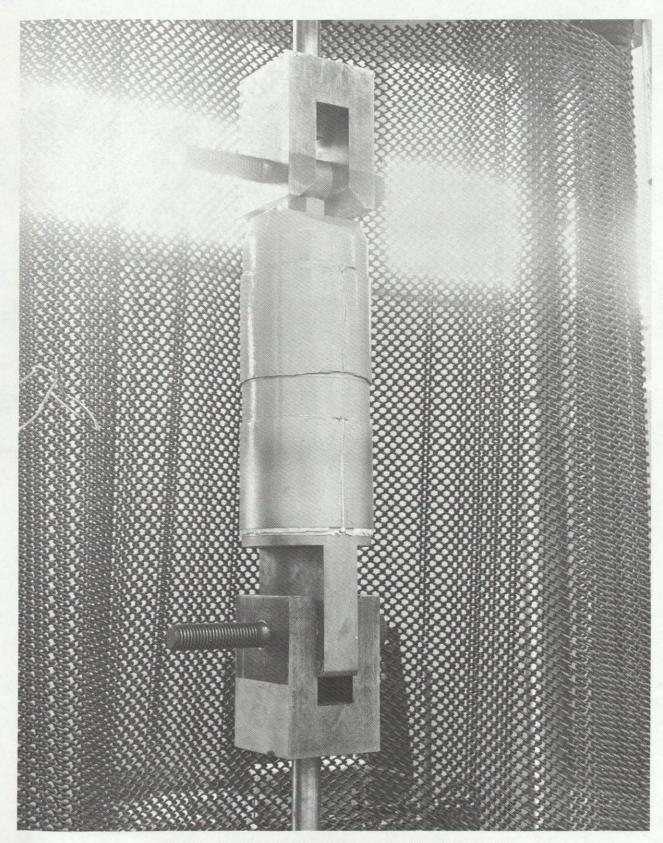
FIGURE 17 ADJUSTABLE END TEST SPECIMEN

The first adjustable-end test fitting (Fig. 17) failed at a tensile load of 88, 900 pounds. The failure, in this case, was in shear of the eyebolt and nut threads (Fig. 18). The eyebolt was made of 4340 steel, heat treated to Rockwell C-34. One nut was bonded to the inside of the end fitting and a jam nut was used on the outside. Swivel adjustment is provided by loosening the jam nut to allow the eyebolt to rotate in the bonded nut. Two 0.030-inch thick aluminum washers were used inside and out to distribute the load to the beryllium. Threads on the eyebolt were one inch-14 NS. The threaded portion of the eyebolt passed through the 1.00 inch diameter hole in the end fitting. The nuts used were Type 303 stainless steel. Stresscoat indicated much more uniform load distribution than on the fixed-end test piece (Fig. 19). Measurements also indicated a more uniform adhesive thickness (0.0035 to 0.0065 inch). This greater uniformity tends to substantiate the probable cause of failure on the first test since the otherwise identical joint did not fail at the higher load on this part.

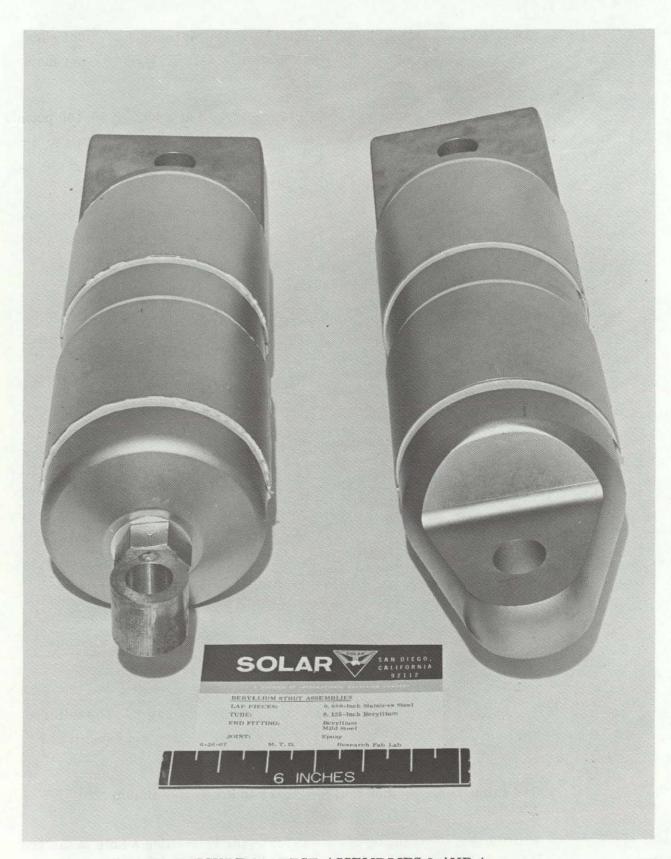
FIGURE 20 TEST ASSEMBLIES 3 AND 4  $\,$

fitting to the test machine. The stresses at maximum load were 3760 psi joint shear, 58,200 psi beryllium tension, and 87,500 psi lap-strap tension. Dye penetrant inspection of the lug area after this test revealed no defects.

Assembly Number 4, with an adjustable end, failed at a load of 50, 400 pounds tension. The failure occurred in the adhesive joint to the beryllium end fitting at a shear stress of 1610 psi. Examination of the failed assembly showed that only 30 to 40 percent of the lap area was bonded. The most likely explanation of the poor bond is that air, entrapped within the tube and joint area, prevented contact between the adhesive film and the beryllium during cure. The factors leading to this conclusion are the pattern of the bonded areas which shows good bond around the periphery of the lap strap with no indication of fingerprints or other signs of handling contamination, the strength exhibited by the bonded area (over 4000 psi) tends to rule out inadequate surface preparation, and the fact that the adhesive film thinned from 0.010 to 0.007 inch indicates that adequate pressure and temperature existed during the cure.
